Evaluation of Thermoplastic Marking Materials

May 2008

DOT/FAA/AR-TN08/22

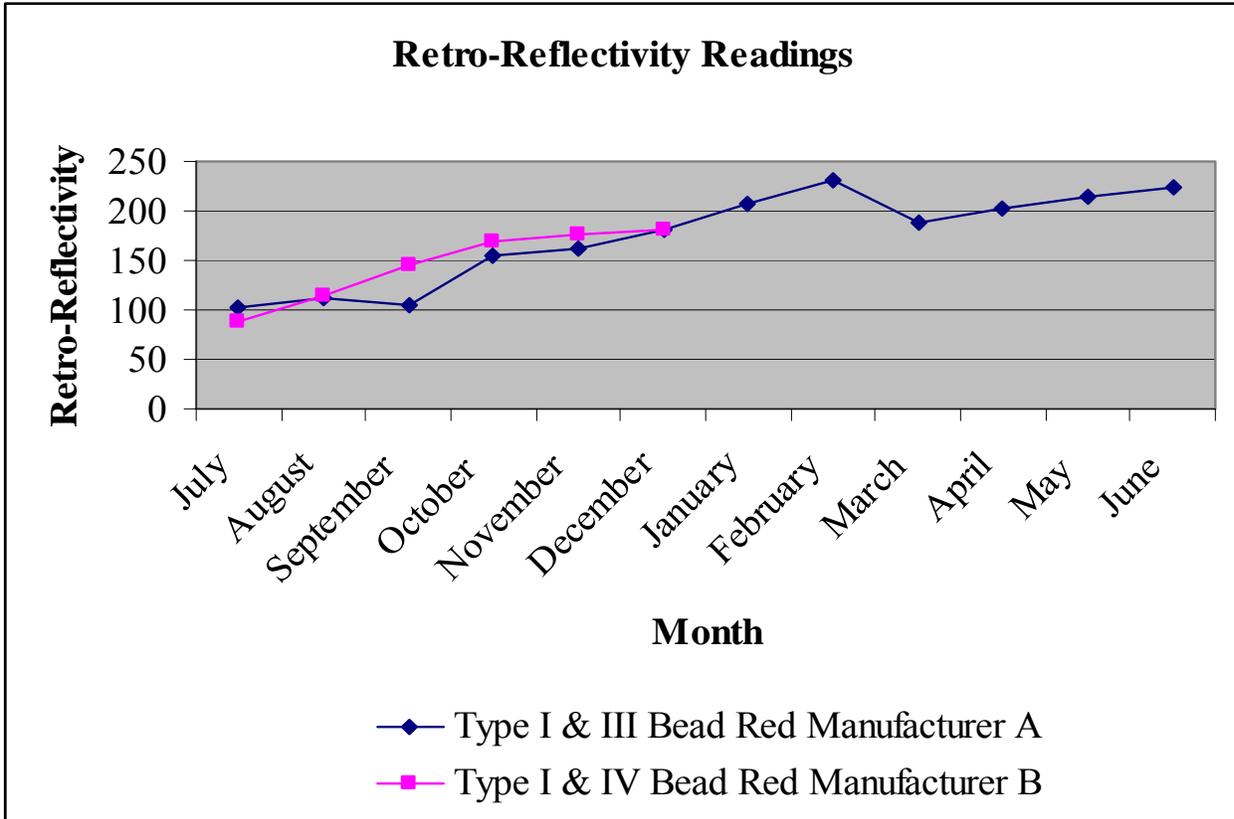
Note: All measurements in millicandela per square meter per lux (mcd/m²/lx).

Figure A-4. Graphic Display for Retro-Reflectivity Readings of Beads for Red Thermoplastic Marking Designations CCRS-1 and CCRS-2 on PCC at FAA William J. Hughes Technical Center

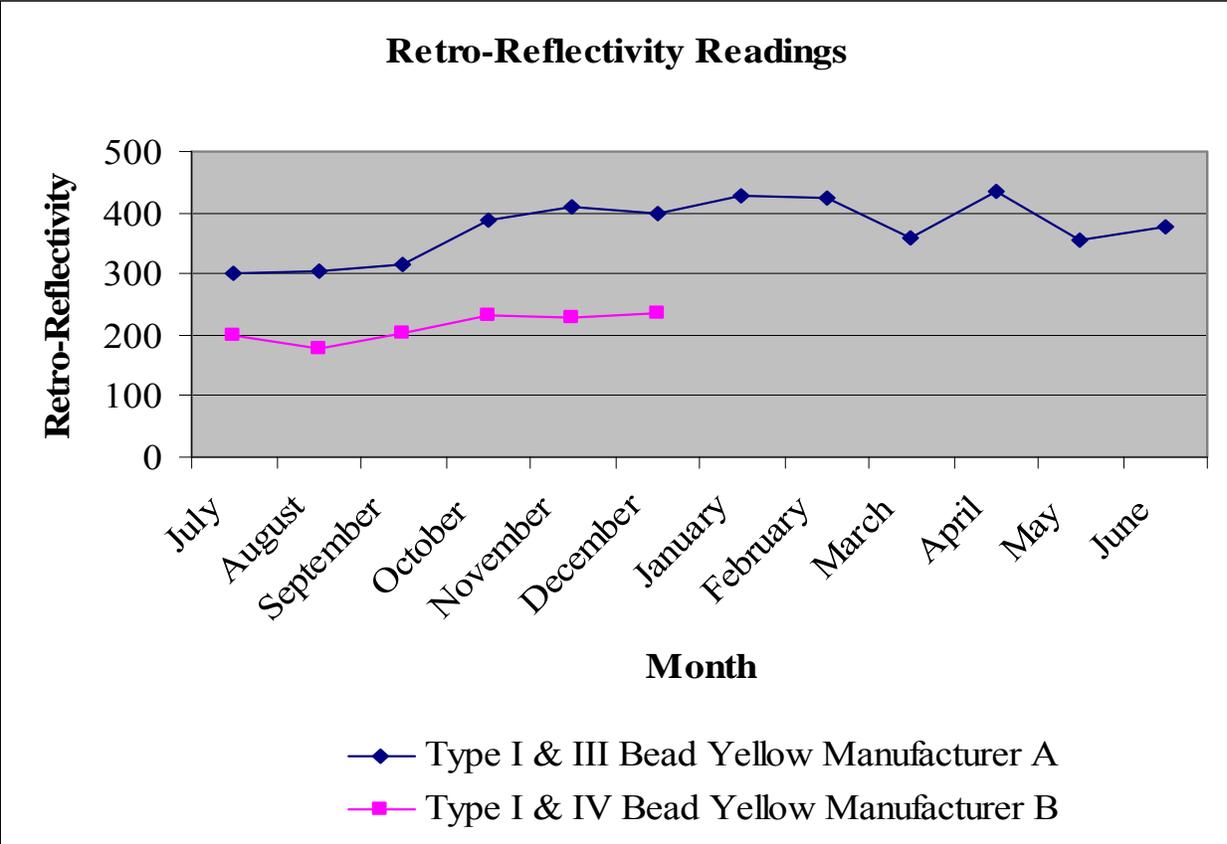
Note: All measurements in millicandela per square meter per lux (mcd/m²/lx).

Figure A-5. Graphic Display for Retro-Reflectivity Readings of Beads for Yellow Thermoplastic Marking Designations CCYS-1 and CCYS-2 on PCC AT FAA William J. Hughes Technical Center

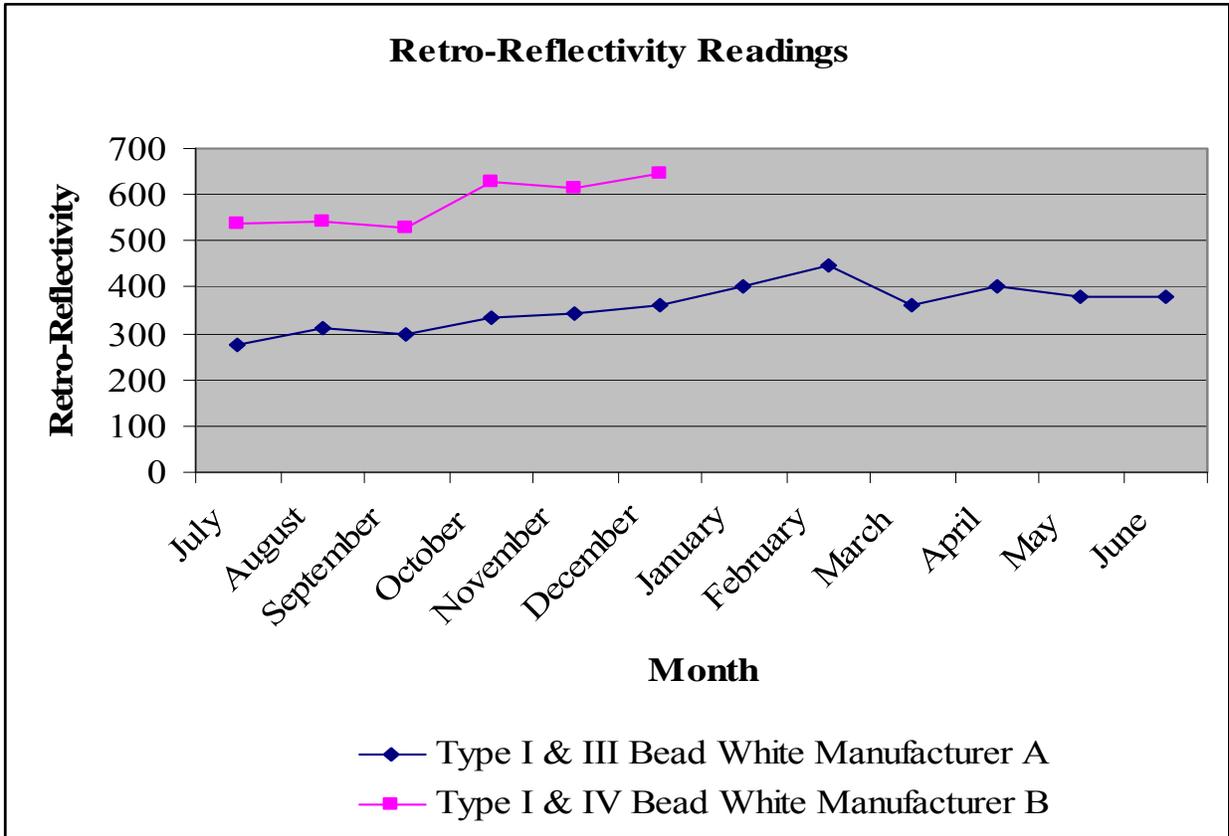
Note: All measurements in millicandela per square meter per lux (mcd/m²/lx).

Figure A-6. Graphic Display for Retro-Reflectivity Readings of Beads for White Thermoplastic Marking Designations CCWS-1 and CCWS-2 on PCC at FAA
William J. Hughes Technical Center

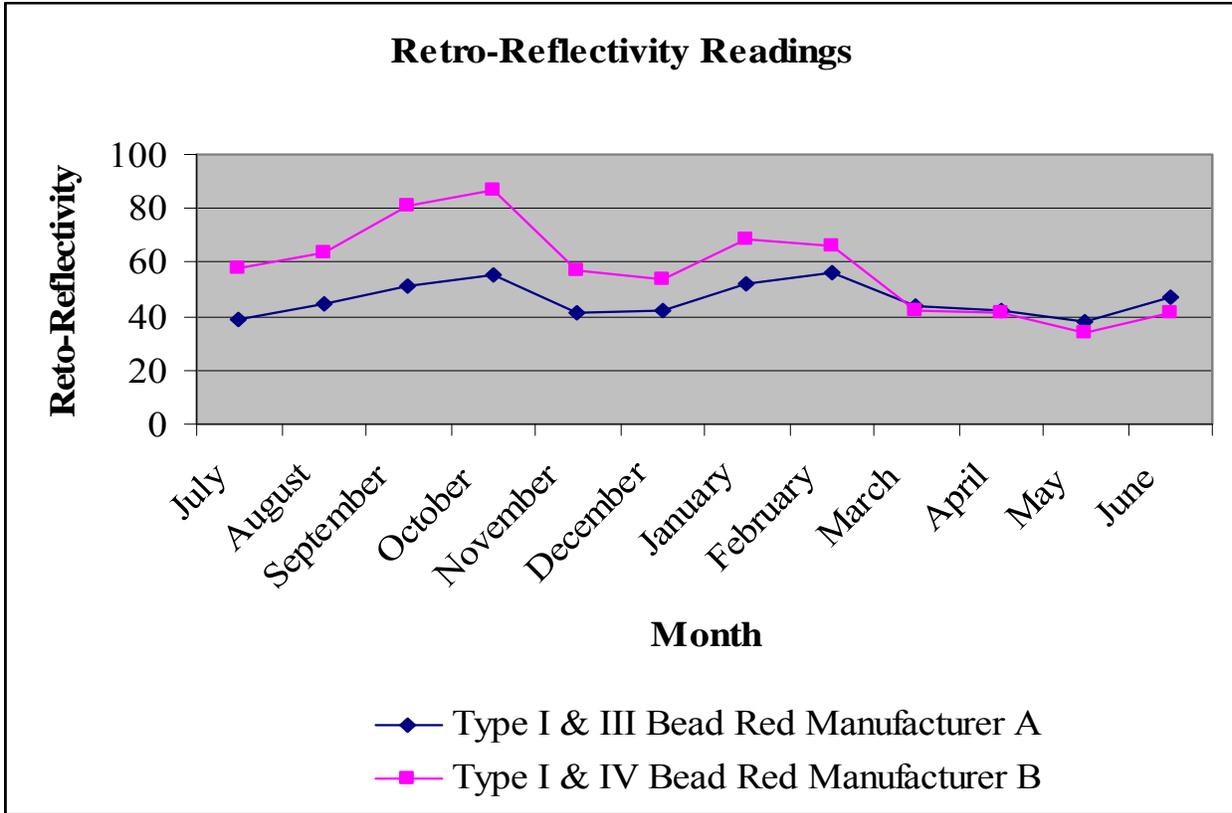
Note: All measurements in millicandela per square meter per lux (mcd/m²/lx).

Figure A-7. Graphic Display for Retro-Reflectivity Readings of Beads for Red Thermoplastic Marking Designations HMRS-1 and HMRS-2 on HMA at FAA
William J. Hughes Technical Center

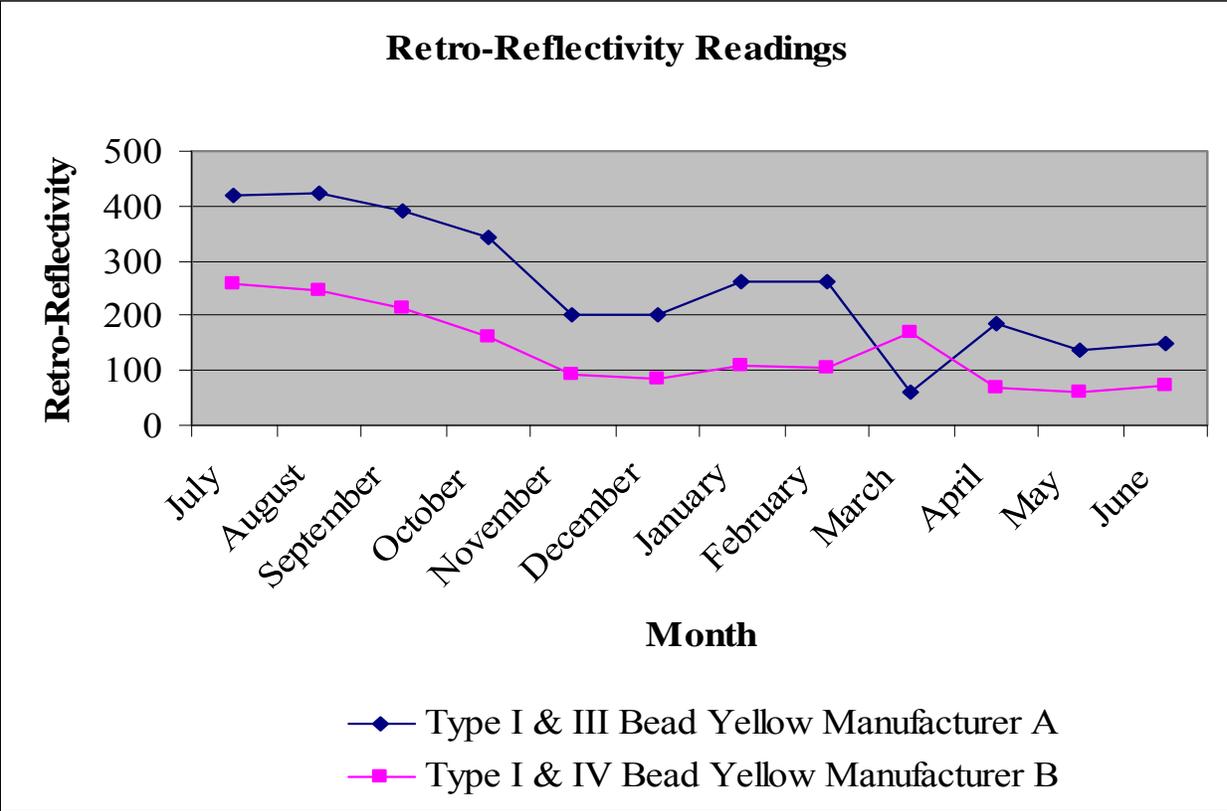
Note: All measurements in millicandela per square meter per lux (mcd/m²/lx).

Figure A-8. Graphic Display for Retro-Reflectivity Readings of Beads for Yellow Thermoplastic Marking Designations HMYS-1 and HMYS-2 on HMA at FAA William J. Hughes Technical Center

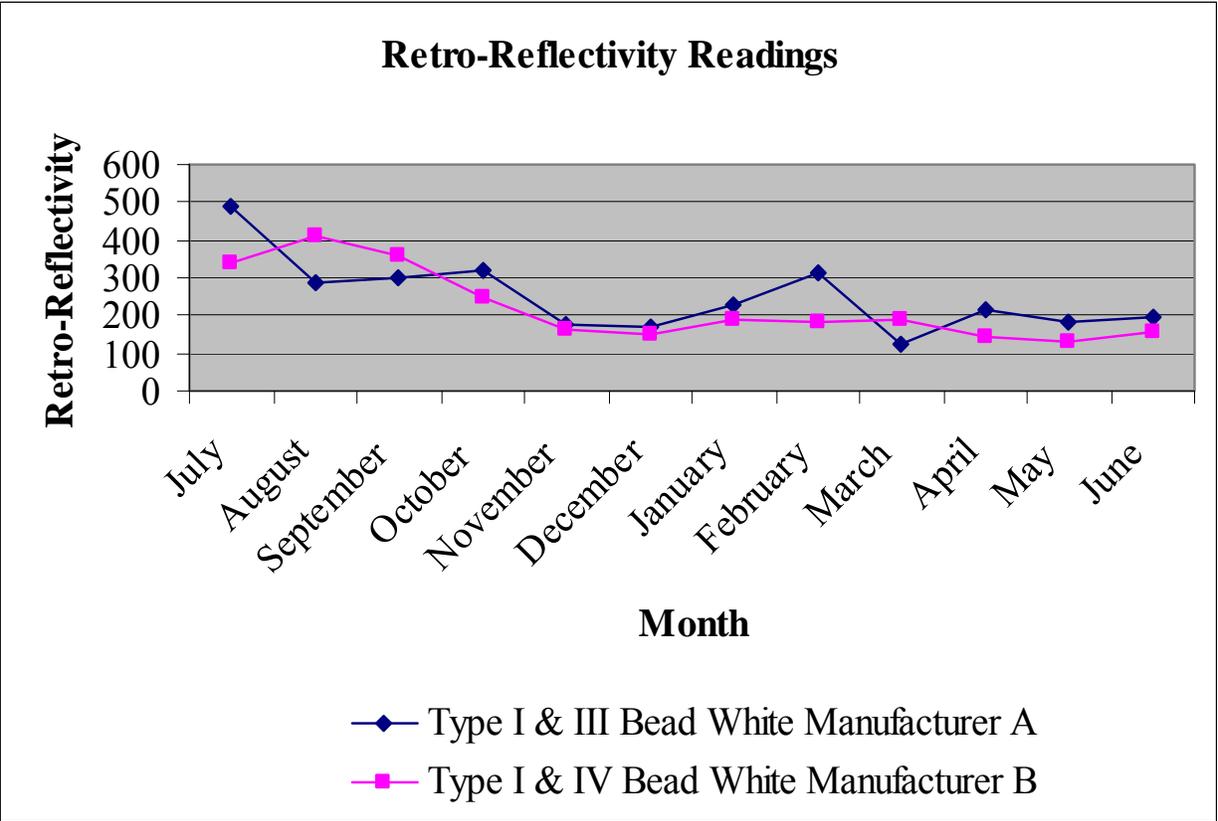
Note: All measurements in millicandela per square meter per lux (mcd/m²/lx).

Figure A-9. Graphic Display for Retro-Reflectivity Readings of Beads for White Thermoplastic Marking Designations HMWS-1 and HMWS-2 on HMA at FAA William J. Hughes Technical Center

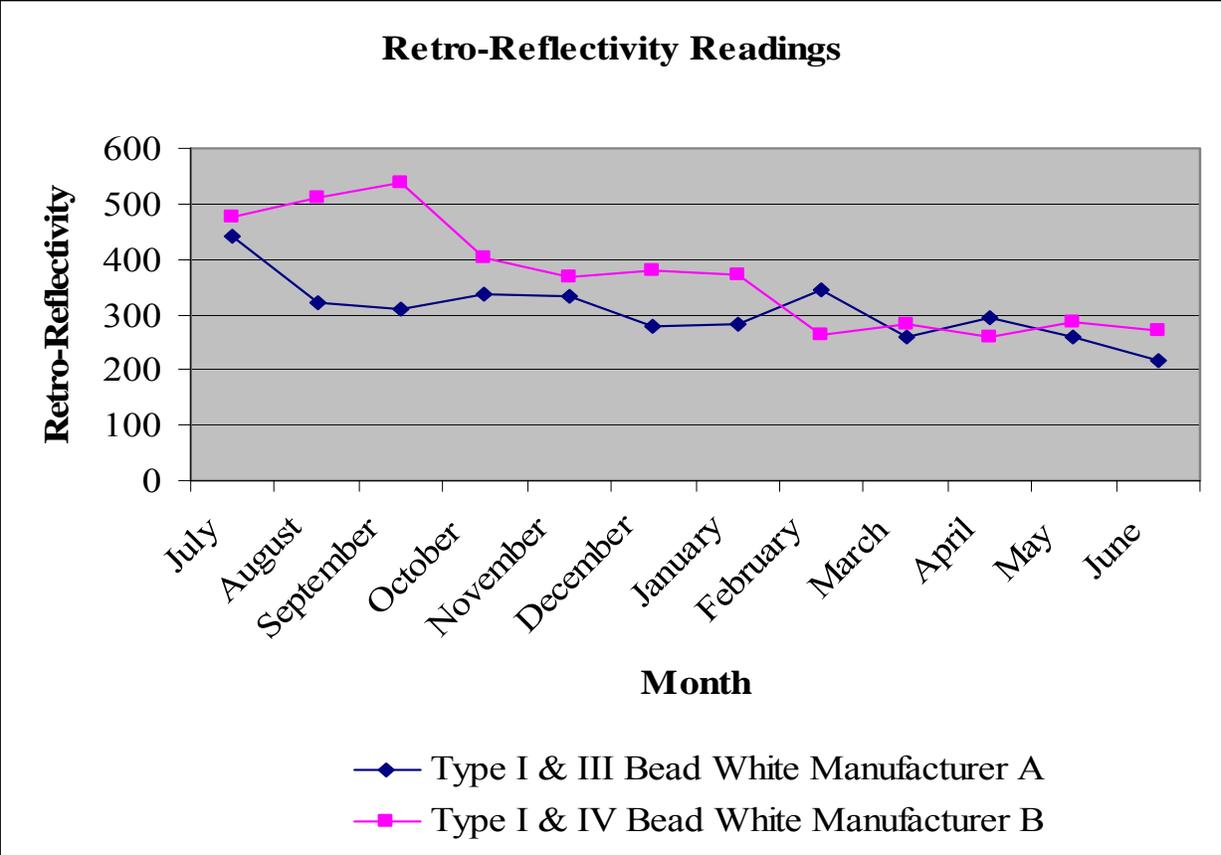
Note: All measurements in millicandela per square meter per lux (mcd/m²/lx).

Figure A-10. Graphic Display for Retro-Reflectivity Readings of Beads for White Thermoplastic Marking Designations HMWSL-1 and HMWSL-2 on HMA at FAA William J. Hughes Technical Center

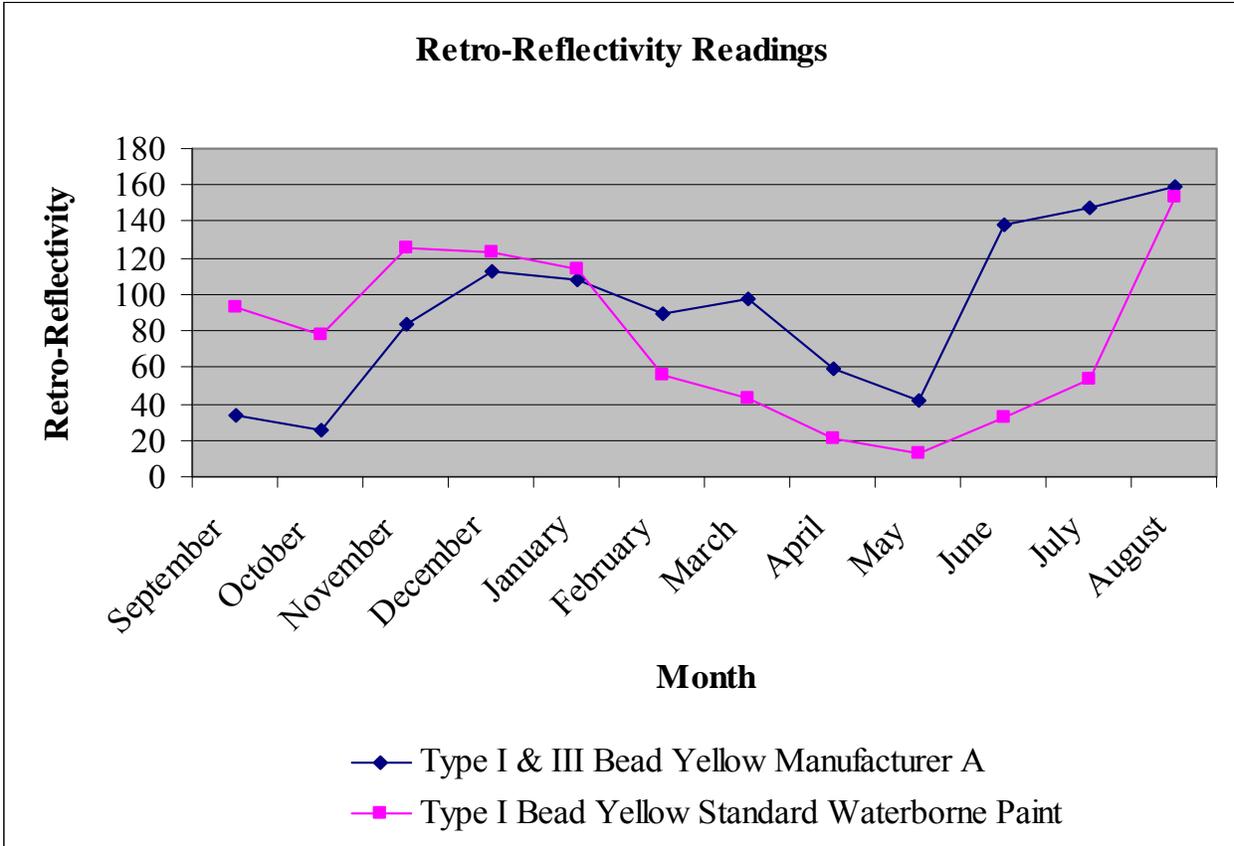
Note: All measurements in millicandela per square meter per lux (mcd/m²/lx).

Figure A-11. Graphic Display for Retro-Reflectivity Readings of Beads for Marking Designation CCRHPS-Yellow and CCRHP-Yellow Paint at EWR

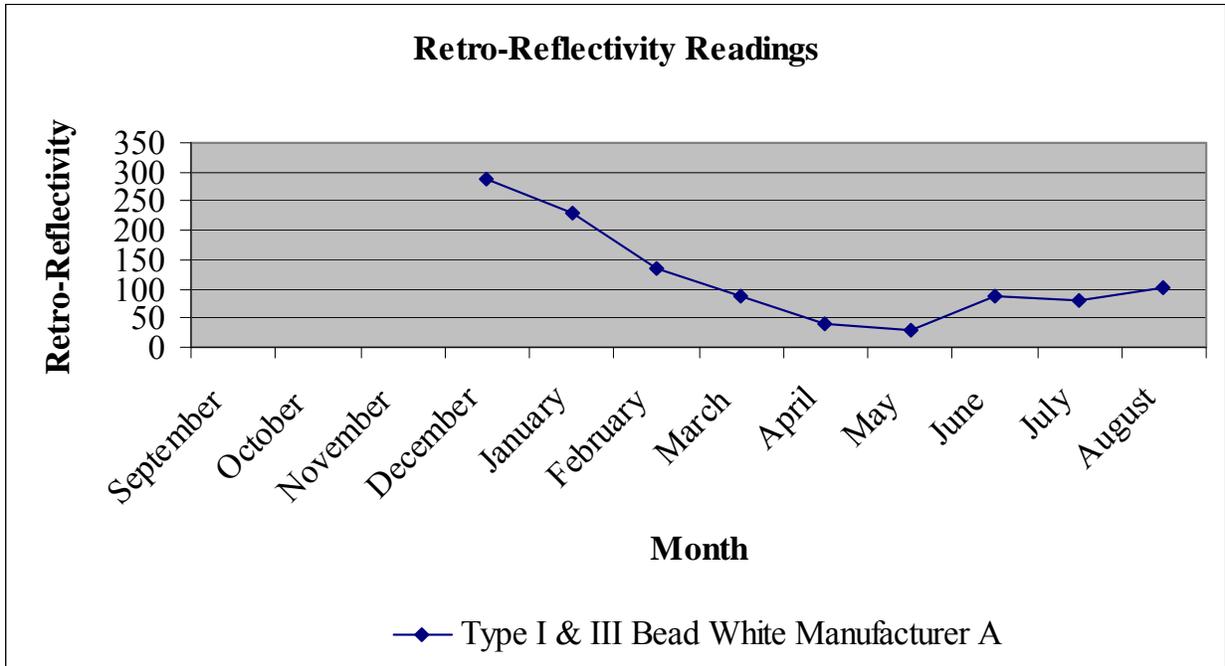
Note: All measurements in millicandela per square meter per lux (mcd/m²/lx).

Figure A-12. Graphic Display for Retro-Reflectivity Readings of Beads for Marking Designation CCRHPD-Yellow at EWR

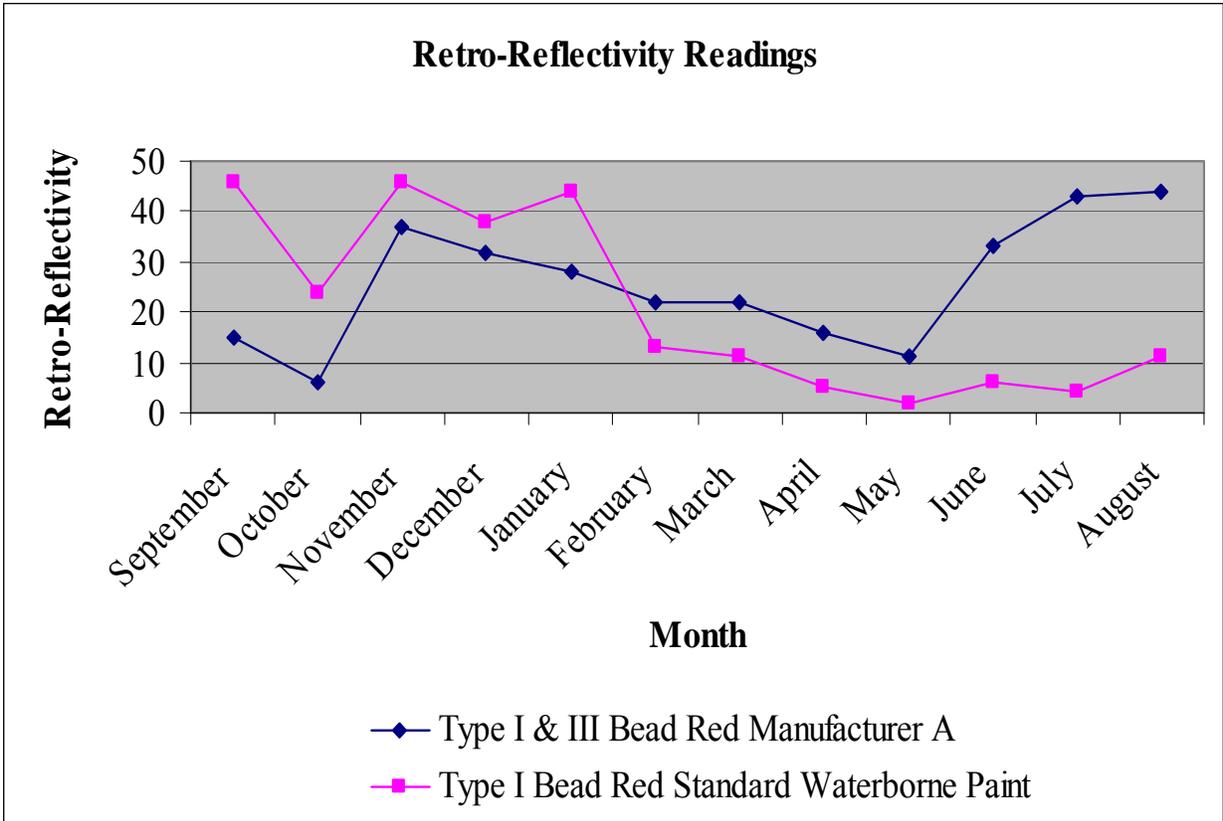
Note: All measurements in millicandela per square meter per lux (mcd/m²/lx).

Figure A-13. Graphic Display for Retro-Reflectivity Readings of Beads for Marking Designation CCRID-Red and CCRID-Red Paint at EWR

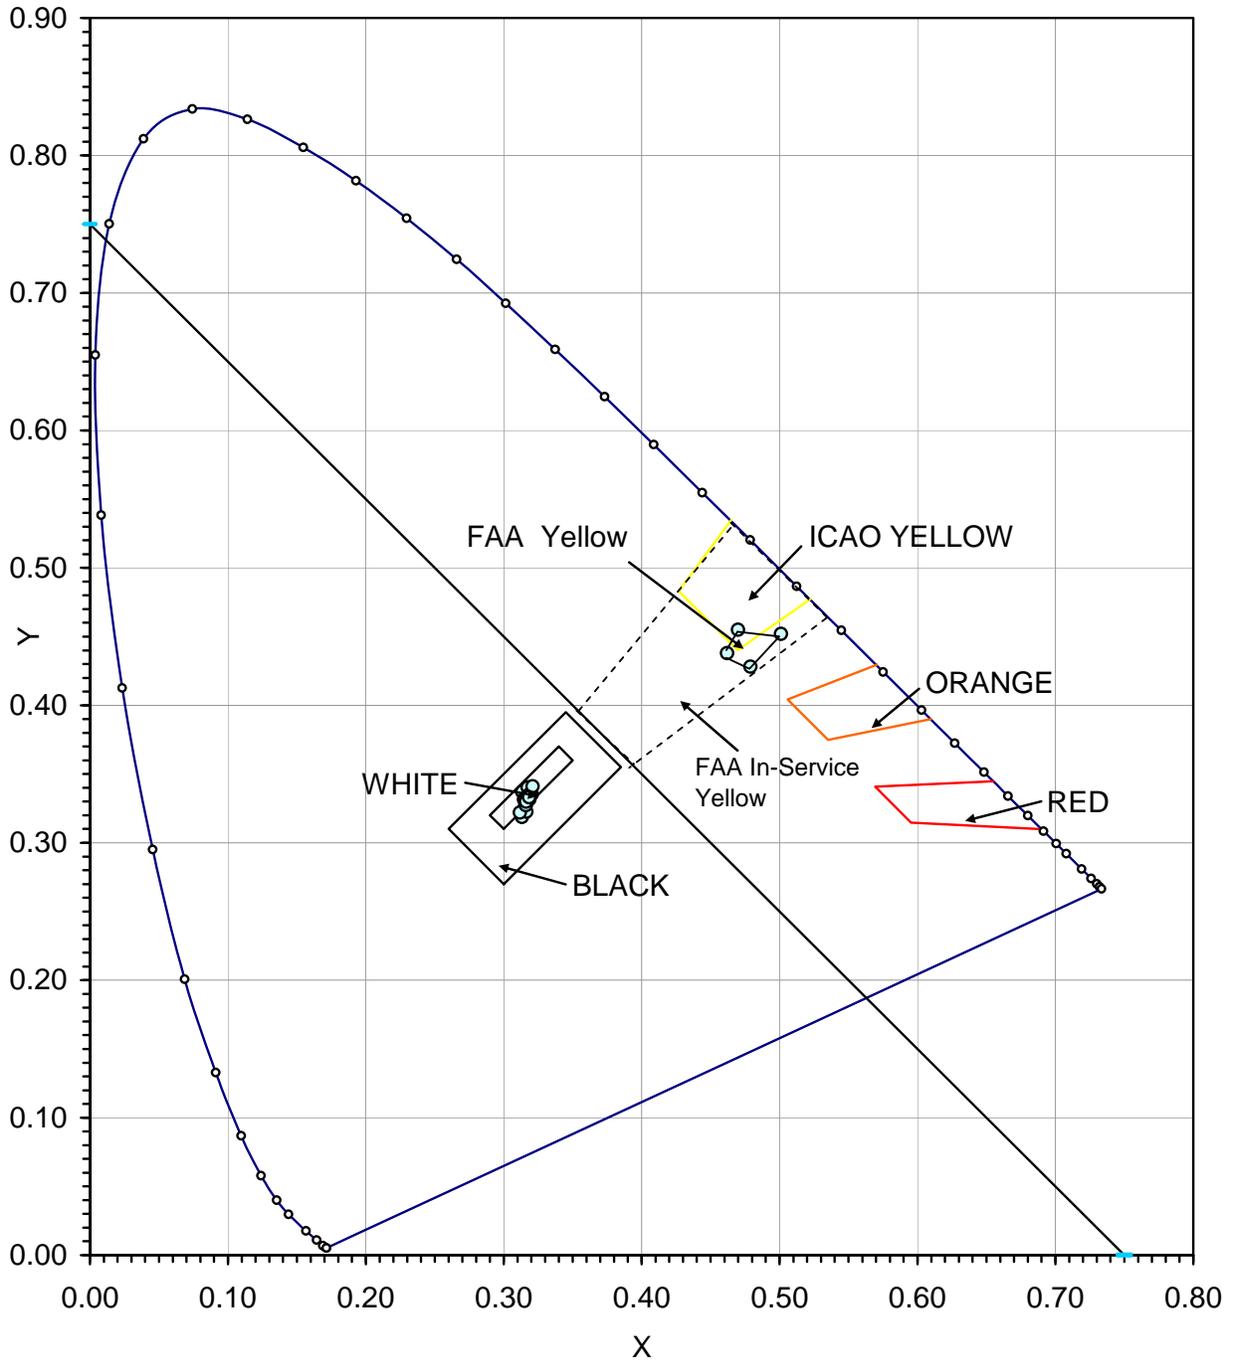
Figure A-15. Chromaticity Readings of CCMNB-1, Movement/Nonmovement Line (Black) at FAA William J. Hughes Technical Center

The x and y coordinates for the chromaticity charts shown in figures A-15 through A-51 have been determined with the following standard conditions:

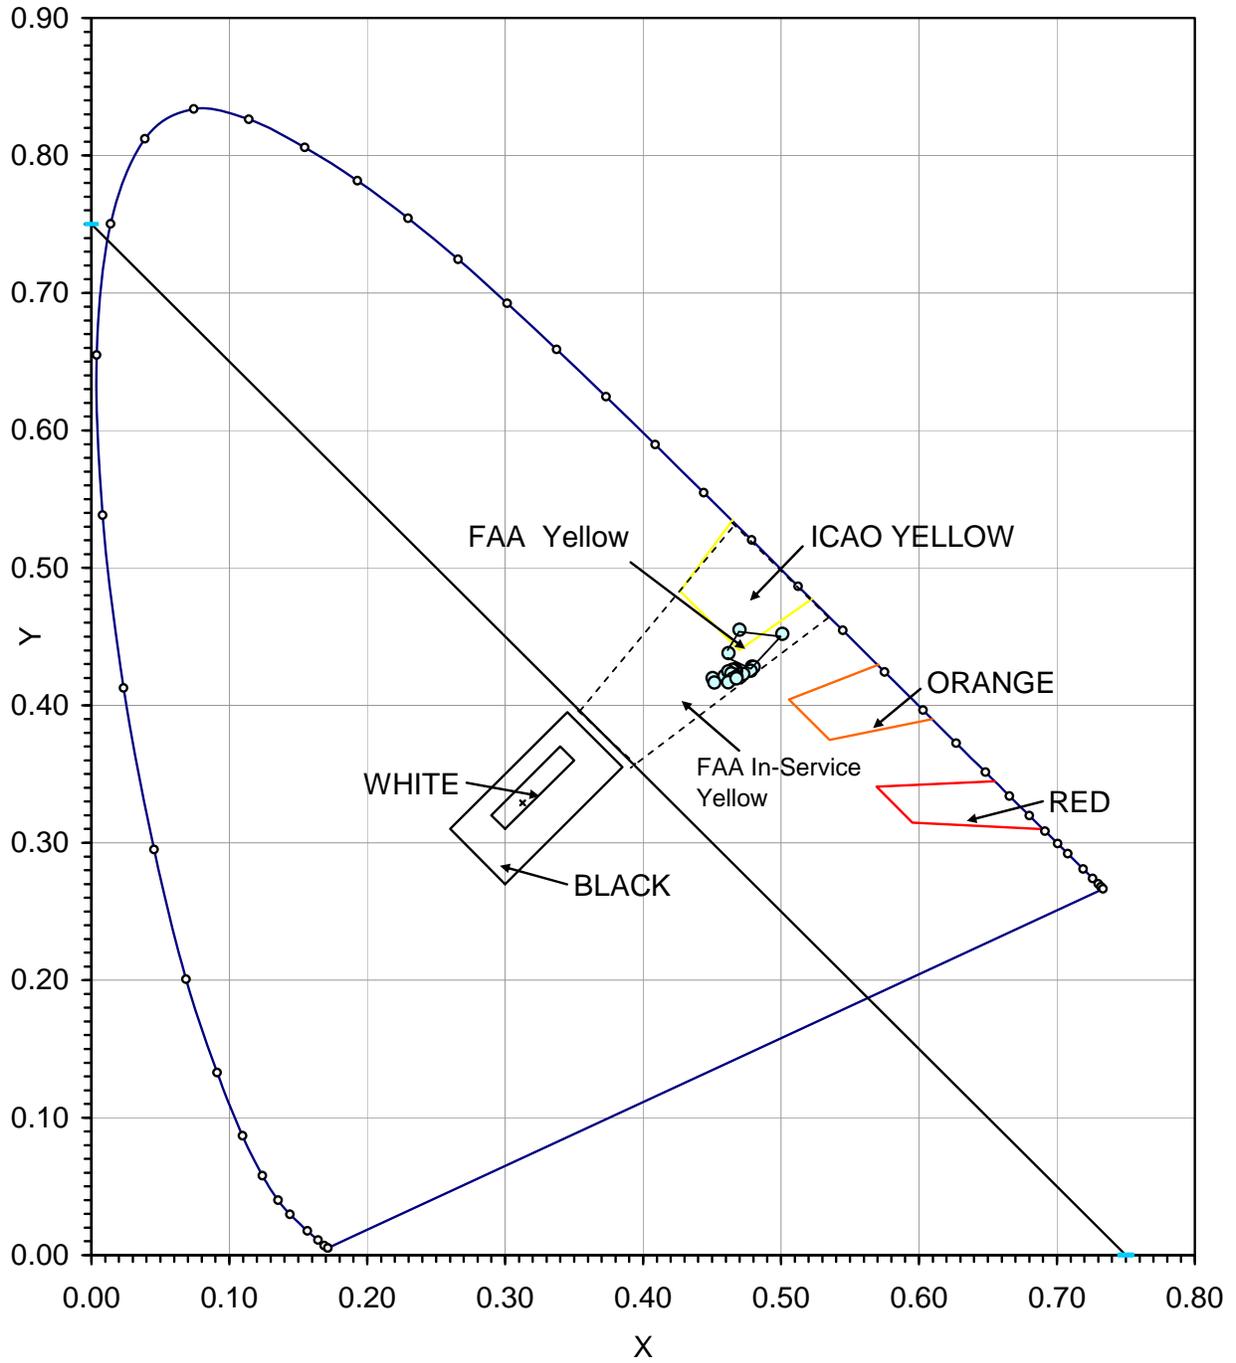
Figure A-16. Chromaticity Readings of CCMNY-1, Movement/Nonmovement Line (Yellow) at FAA William J. Hughes Technical Center

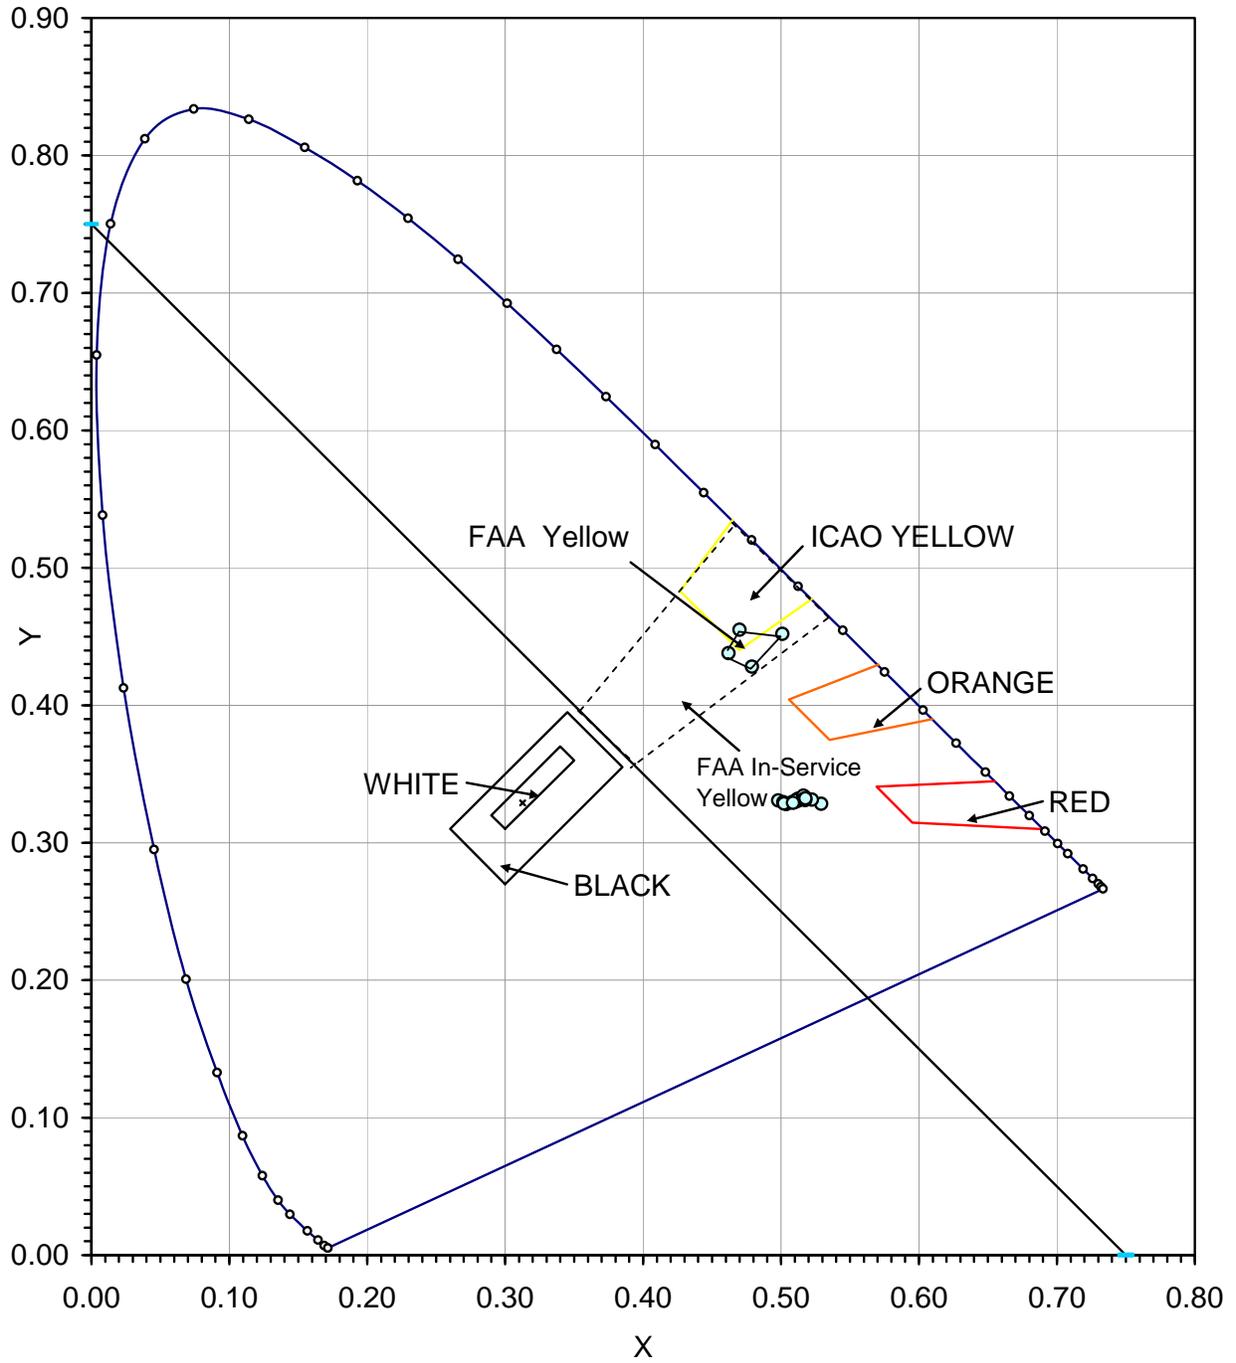
Figure A-17. Chromaticity Readings of CCAPD6R-1, Aircraft Parking Designator #6 (Red) at FAA William J. Hughes Technical Center

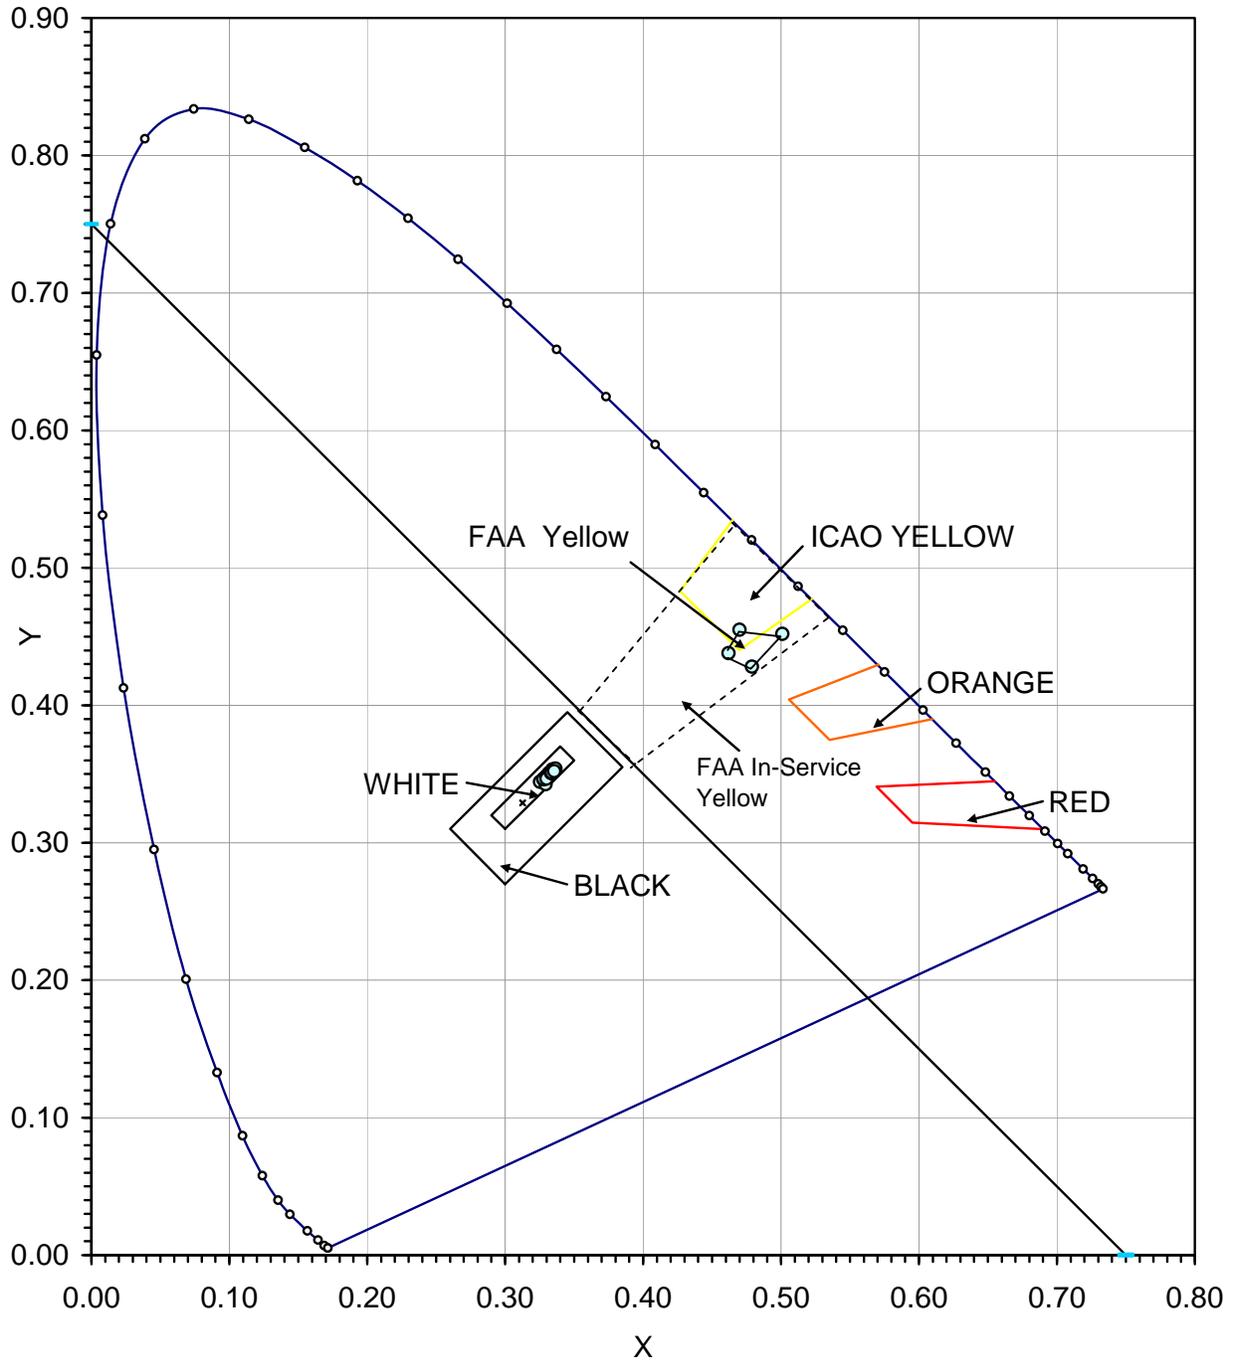
Figure A-18. Chromaticity Readings of CCAPD6W-1, Aircraft Parking Designator #6 (White) at FAA William J. Hughes Technical Center

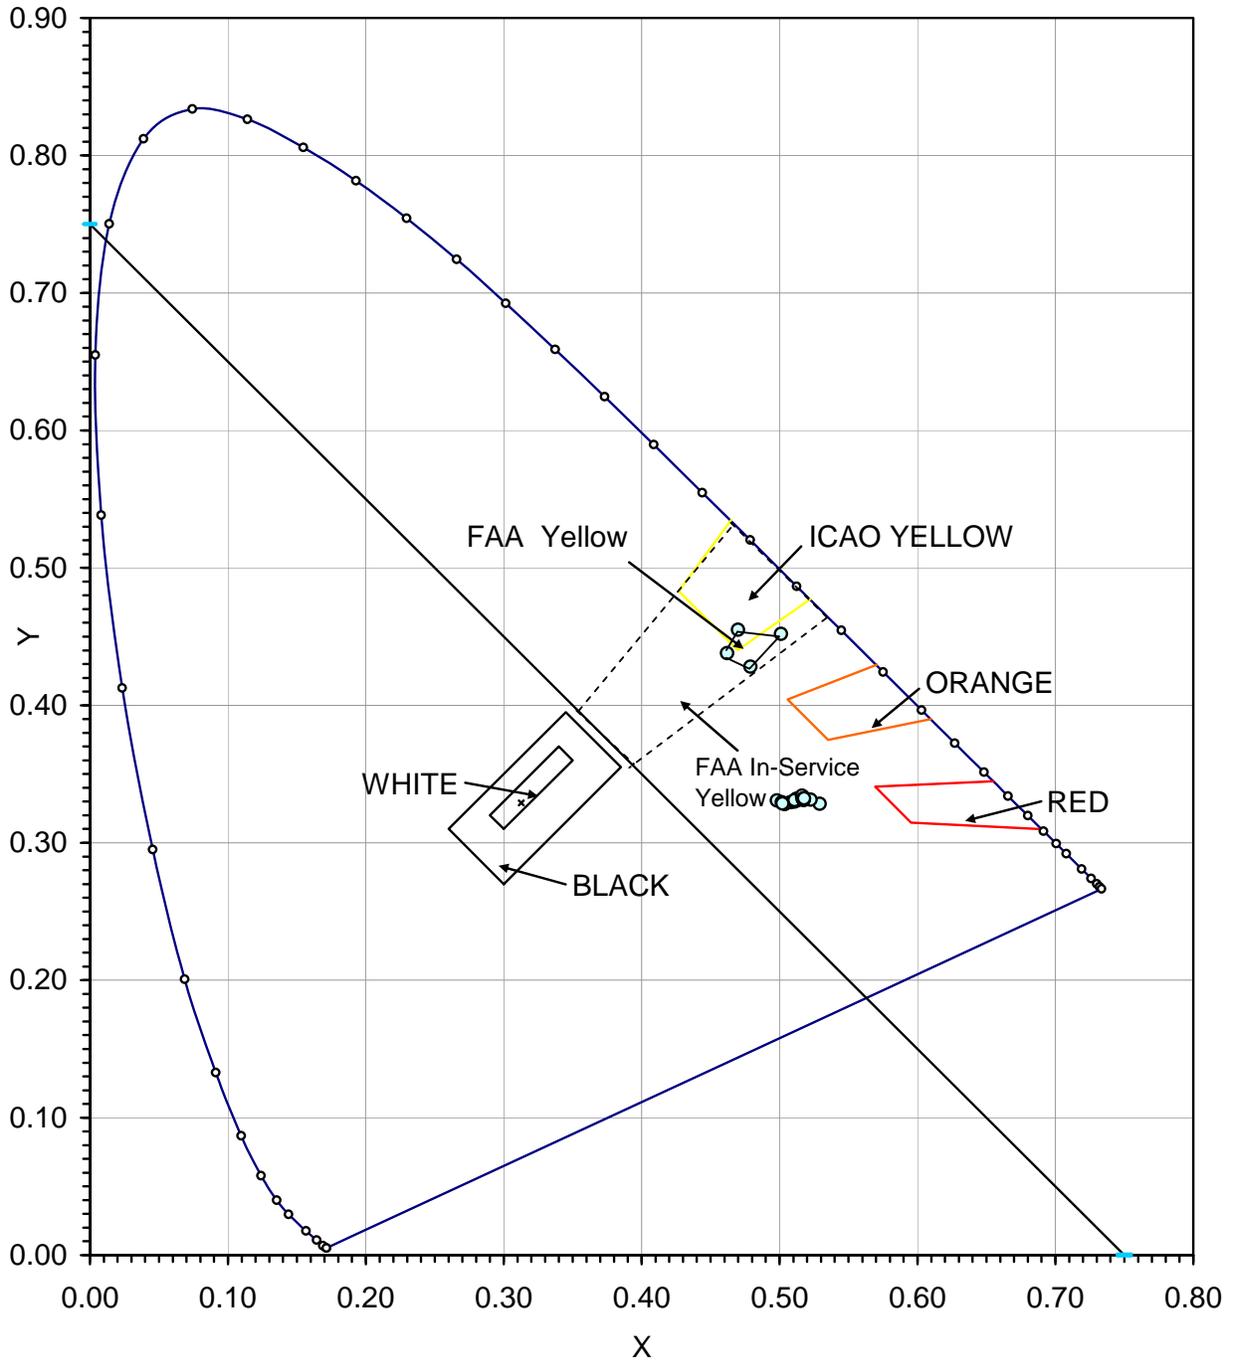
Figure A-19. Chromaticity Readings of CCAPD7R-1, Aircraft Parking Designator #7 (Red) at FAA William J. Hughes Technical Center

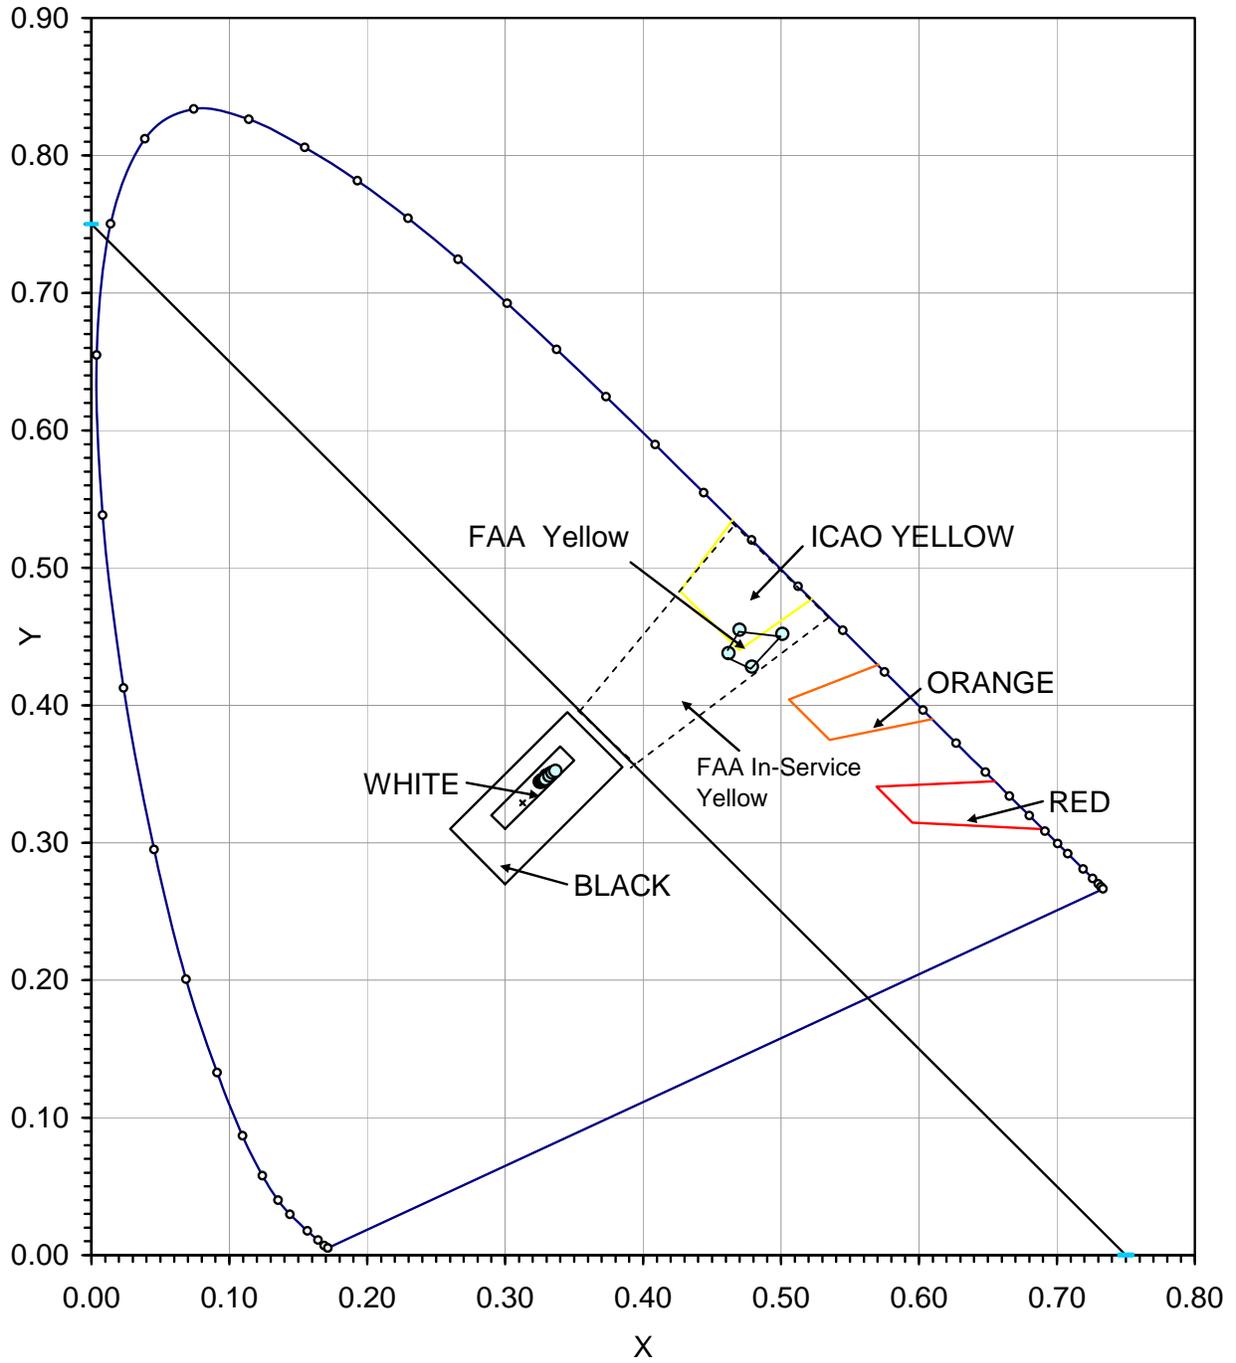
Figure A-20. Chromaticity Readings of CCAPD7W-1, Aircraft Parking Designator #7 (White) at FAA William J. Hughes Technical Center

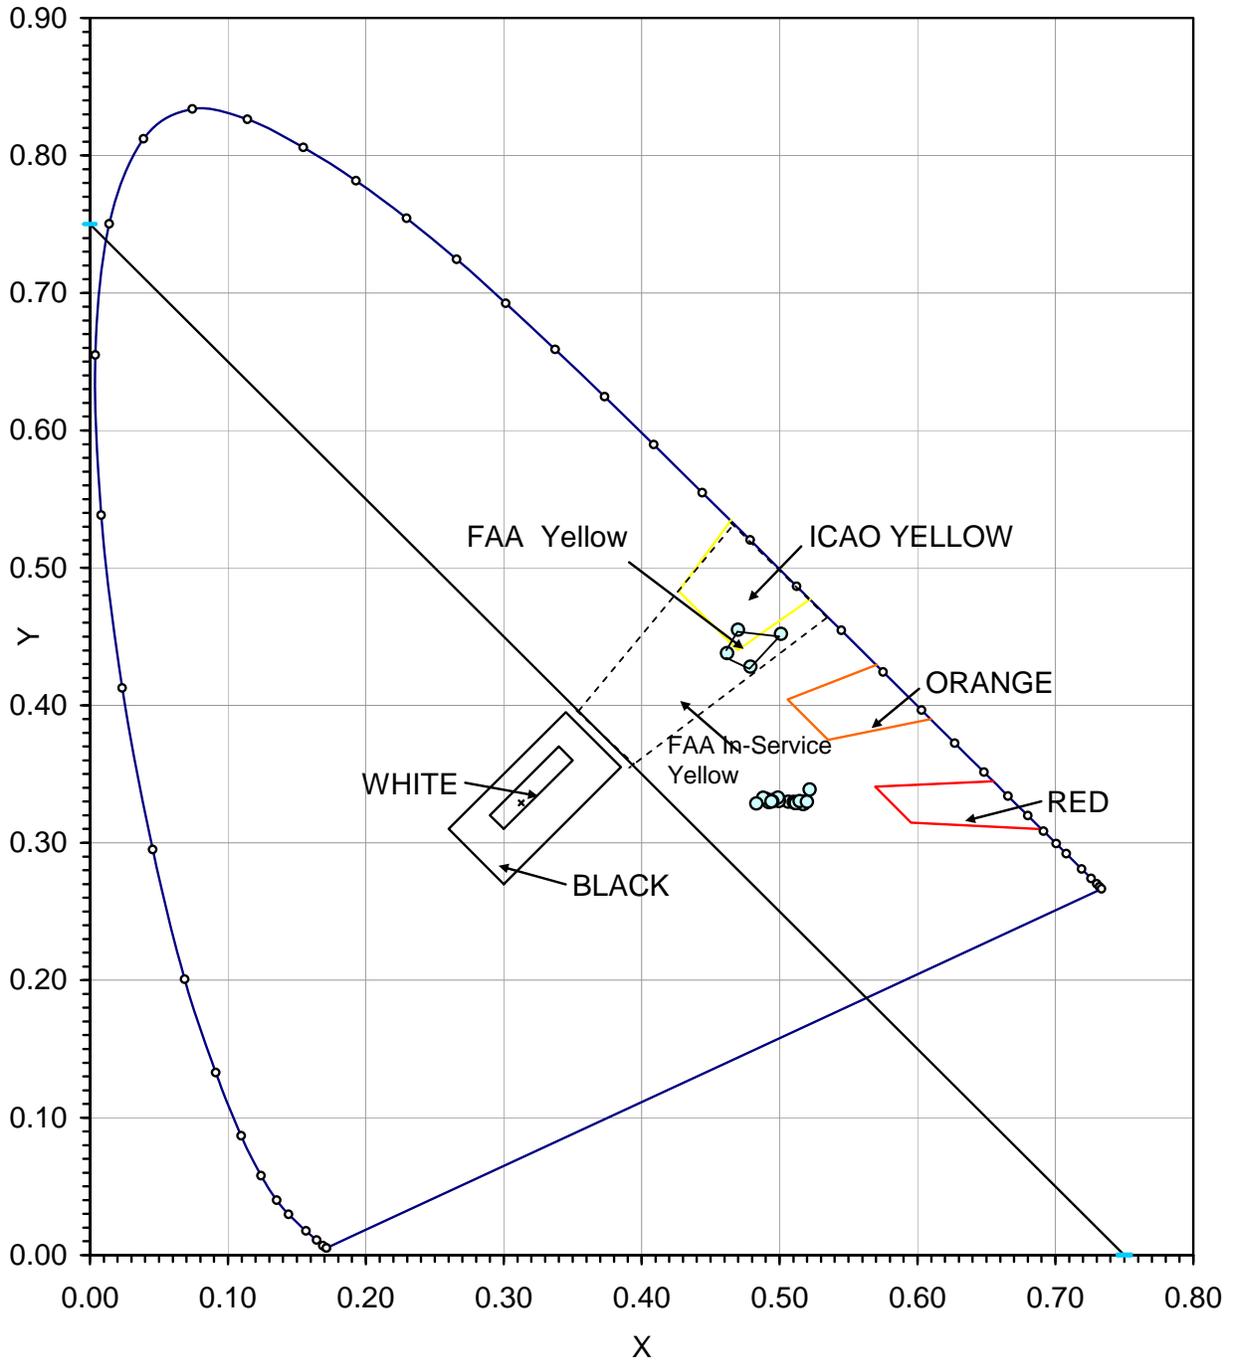
Figure A-21. Chromaticity Readings of CCRS-1, 3-Foot Stripe (Red) at FAA William J. Hughes Technical Center
